## Post-publication careers: follow-up expeditions reveal avalanches at Dyatlov Pass

Having shed new light on an old mystery—how nine Russian mountaineers perished in the Urals in 1959—Alexander Puzrin and Johan Gaume got hooked. Three expeditions later it is clear that avalanches are not exceptional at Dyatlov Pass.

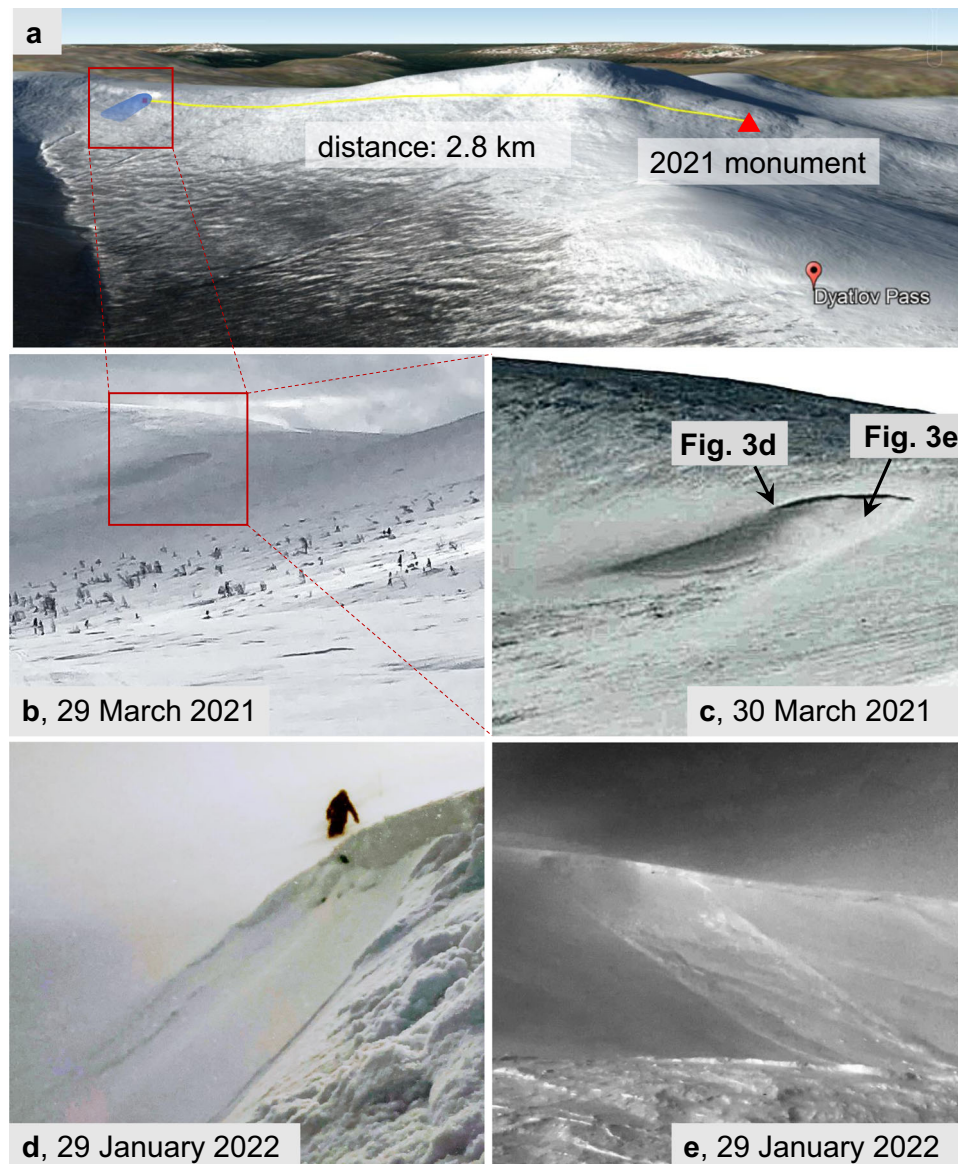
**Fig. 3 Avalanches near Dyatlov Pass.** **a** Location of the area where avalanches were observed. Source: Google Earth © 2021 Maxar technologies Landsat/Copernicus. **b** Picture taken by Dmitriy Borisov on the 29th of March 2021 from the Dyatlov Pass. The zone highlighted in red is located ~3 km away from the tent. **c** Picture extracted from a video taken by Matteo Born (RSI movie director), the day later, i.e., 30th March 2021. **d** Picture of a crown tensile fracture on the left side of this slope taken by Dmitriy Borisov on 29th January 2022. **e** Picture of a small slab avalanche in the middle of the slope by Dmitriy Borisov on the same day (29th January 2022).

And here the story takes an almost mysterious turn. In October 2021, we were contacted by a Russian mountain guide, Dmitriy Borisov, who had photographed on 29th of March 2021 a peculiar feature on the western slope of a nearby mountain (Fig. 3a, b), about 3 km away from the tent location. It looked like a local depression in the slope with probable avalanche traces. But we were concerned that it could also be a shadow from a cloud. Then

the RSI film director Matteo Born went through the footage he took for the documentary during his own winter expedition and accidentally discovered the same features only in a higher resolution (Fig. 3c and Supplementary Movie 1)—taken during the following day, on the 30th of March! It is highly unlikely that a cloud would stay in the same place for close to 24 h. Although it is difficult to confirm the type of snow slope instability based on this picture's resolution, the dark shaded zone below the ridge could be a tensile crown fracture resulting from one or several slab avalanches. A dozen international avalanche scientists or practitioners whom we talked to suggested that these could be classified either as a snow cornice, cornice falls or small wind slab avalanches.

area in Fig. 3b, c. On the 28th of January 2022, exactly 63 years after the Dyatlov group was seen alive for the last time, two professional mountain guides from Ekaterinburg, Oleg Demyanenko and Dmitriy Borisov, left for the Dyatlov Pass on two snowmobiles. The initially favorable weather conditions quickly deteriorated, with wind and temperatures becoming similar to those on the night of the 1959 tragedy. Several times, the 300 kg snowmobiles and their drivers were overturned by wind gusts. Visibility became extremely poor. And then, when after a few failed attempts the two mountain guides approached their destination, the visibility briefly improved and revealed traces of two snow slab avalanches (Fig. 3d, e and Supplementary Movie 2).

doubts remain for the March 2021 instability type in Fig. 3b, c, the outcome of the January 2022 expedition is clear: the traces of two new snow slab avalanches were observed for weather conditions apparently similar to those on the night of the Dyatlov incident, during the same time of the year. The first slab avalanche (Fig. 3d) is located on the left side of the slope, and has a crown thickness of about 1 m. The second one (Fig. 3e and Supplementary Movie 2), which was observed in the middle of the slope, appeared to have a smaller crown thickness, close to the one predicted in our model<sup>1</sup>. It slid along a smooth weak interface with an older compacted snow and was very likely triggered by a local cornice fall. Oleg and Dmitriy report that this second avalanche was practically invisible after less than an hour, as it was covered by the wind-transported snow. They estimate that the avalanche released less than an hour before their arrival. No wonder then that the Dyatlov rescue team could not find signs of an avalanche 3 weeks after the incident. This also explains why no avalanches have been observed there before: in such severe weather conditions the Pass cannot be easily accessed by hikers, while traces of small slab avalanches disappear within few hours.
